Application of ERT and Aerial Photographs Techniques to Identify the Consequences of Sinkholes Hazards in Constructing Housing Complexes Sites over Karstic Carbonate Bedrock in Perak, Peninsular Malaysia

Riyadh R. Yassin¹, Ros Fatimah Muhammad¹, Samsudin Hj Taib¹ & Omer Al-Kouri¹

¹ Department of Geology, Faculty of Science, University of Malaya, 50603 Kuala Lumpur, Malaysia

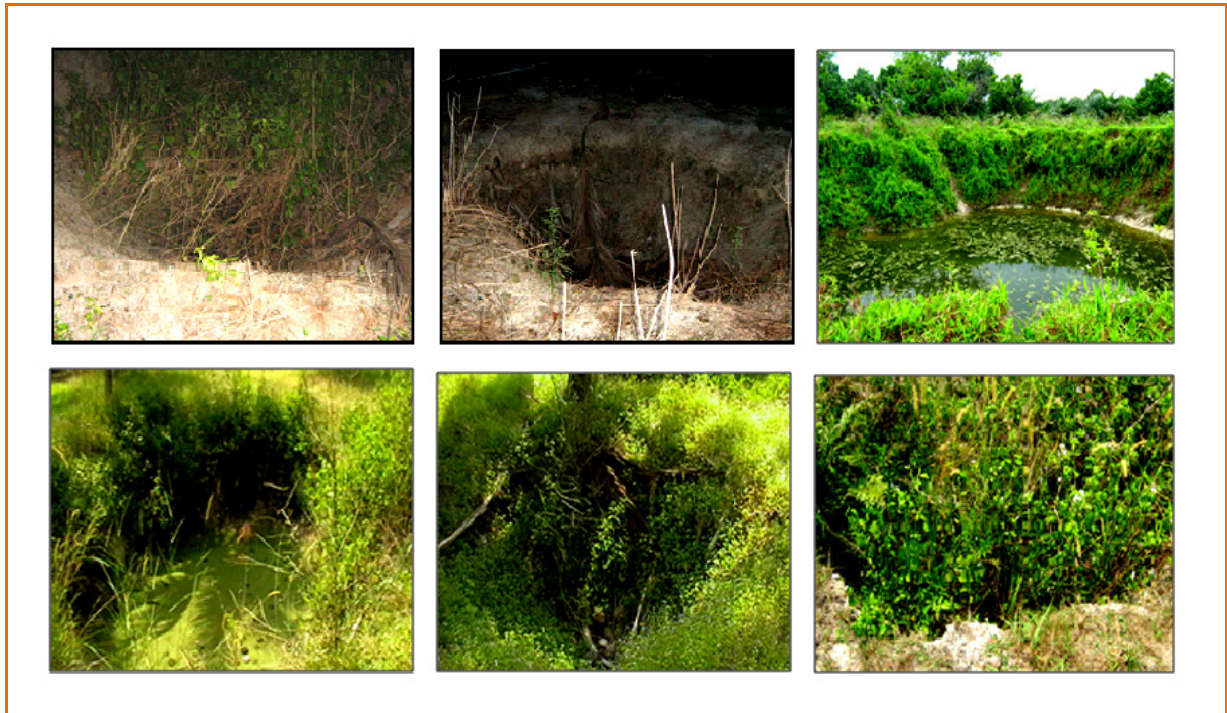
Figure 8. Land Photographs viewing a number of sinkholes that identified as water in-fill, empty and covered with vegetation were determined as small and narrow in construction site #2

During the ground inspection at site #2, two sinkholes were discovered, but not recognized in aerial photographs and satellite images, as adjacent small plants have enclosed it. One of these sinkholes has a diameter of ~7 m – 10 m., water in-filled, of visually undetermined depth, are recognized and proven as a sinkhole with a narrow showing throat, positioned in the south west flank of this site. The other sinkhole has a diameter of ~35 m – 40 m, positioned in the north east side of this site, was in-filled with wet clay and other material of sediments due to karst activity, raised a question that this sinkhole might be linked in the subsurface to one or more of the large tabular conduits or channels, and the presence of cavities or voids of undetermined depth. Clay, or air in-filled karstic sinkhole or cavities were present, which could compromise the veracity of this site. The south section of this site is littered with soil cover collapses. The sinkholes that were identified as water in-fill or empty and some covered with vegetation were determined as small and narrow in construction site #2 viewing in Figure 8.

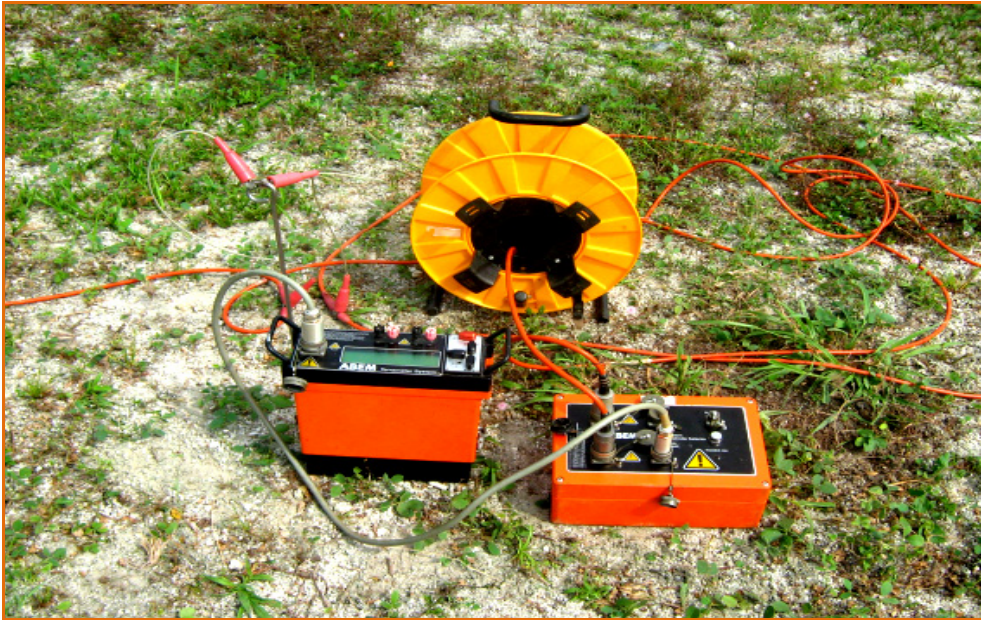
Figure 9. Viewing the instrument type SAS1000 applied in geophysical survey technique

In a distinctive survey, most of the fieldwork involves laying out the cables and electrodes. After doing that, the measurements are taken automatically and stocked into the computer. This resistivity procedure usually gives a better grouping of spatial resolution and depth of study in karst terrain than any other geophysical technique.

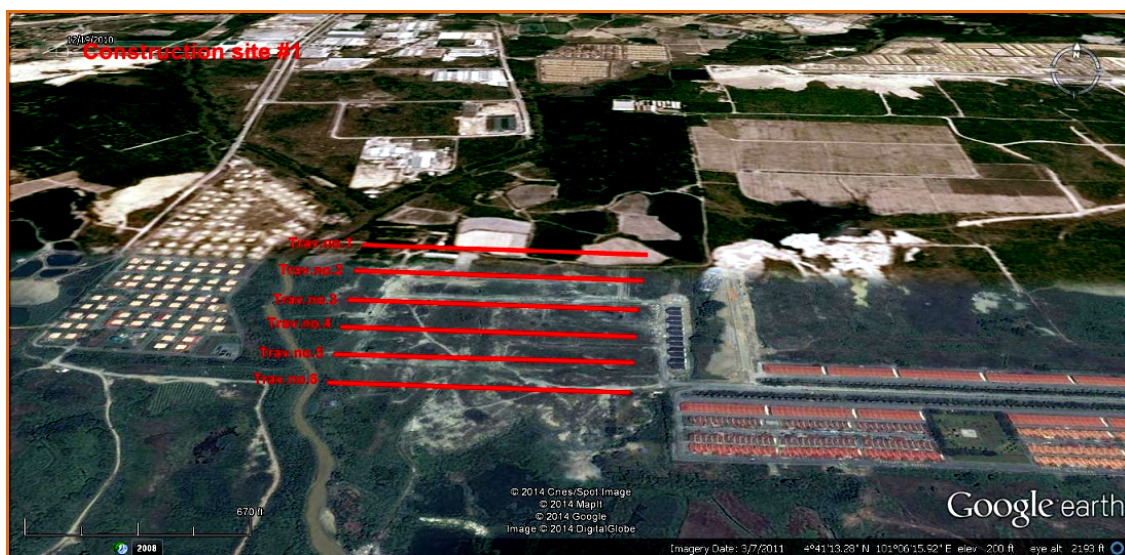
Figure 10. Google earth satellite images (2011) viewing the location of resistivity profiles in construction site #1

Six electrical resistivity traverses or profiles, Profile-1 to Profile-6, were controlled over and along the survey area in site #1. The direction of these profiles in (N90° W), and the level of those lines are shown in the location map, illustrated in Figure 10. The electrical resistivity data accumulated along the two dimensional (2-D) electrical resistivity profiles were determined to be in excess of, or beneath the sinkhole, using a 41-channel array in the Wenner configuration. The length of each profile was 200 m, with an electrode spacing of 5 m, on average, spaced at 25 m between each profile. The total length of all profiles in this site was 1200 m, covering an area of 30000 m²; 190 data points were composed for each (41-electrode) in one profile, and on average, about 1140 data were composed for a total six profiles in this site.

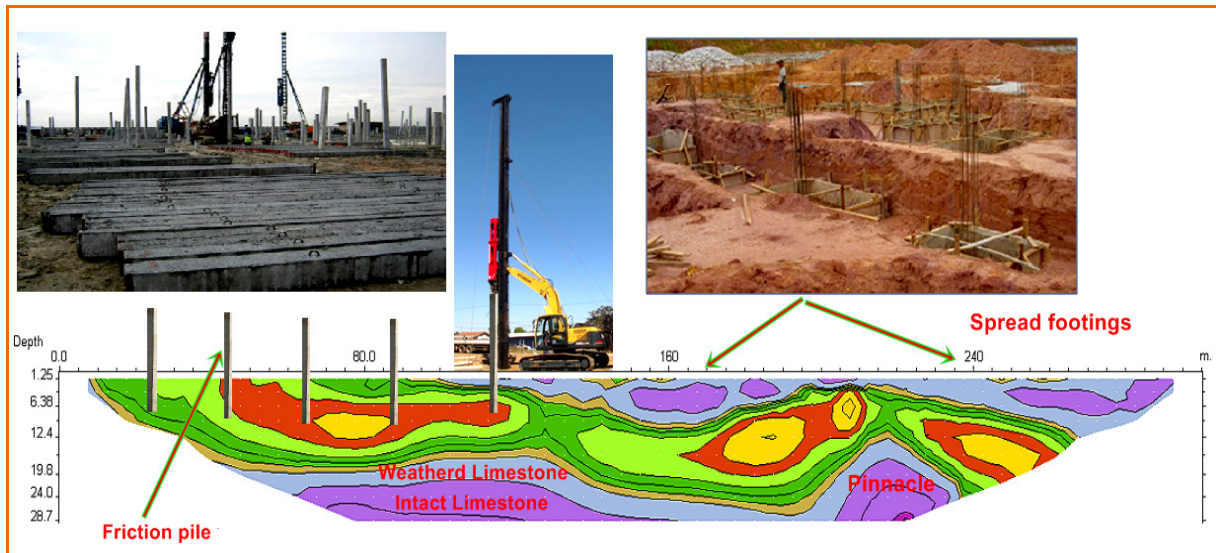
Figure 17. Presenting the Skin Friction Piles and spread footings under construction in construction site #2

Skin friction piles can be driven down through the softer material to specified depth in this construction site. In this type of pile, the load bearing resistance derived on pile mainly from skin /friction resistance along the side of the pile shaft, so that the friction of the soil against the sides of the pile is enough to resist any downward movement.

The high capacity of friction piles has developed a considerable load carrying which is a function of vertical support from skin friction developed between the surface of buried pile shaft area and the contact with the surrounding soil. The Skin Friction Piles that is driven into softer soil (silty, clay and sandy soils) without come across as a stiff or intact layer (bedrock) in construction site #2 presented in Figure 17.
