# **Assessment of the Characteristics of Slum in the Core of Akure, Nigeria**

**Original Research Article**

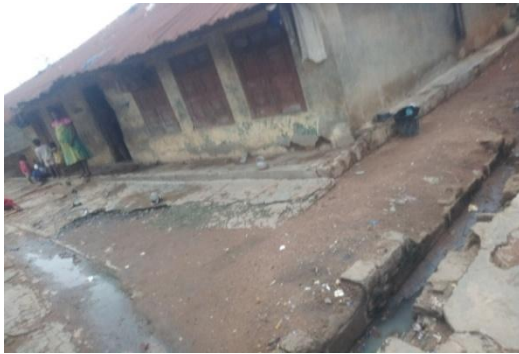
**Fig. 4. Tenement Building at Odokoyi**  
 Source: Author's Field Survey, 2022

Analysis on the types of houses the respondents occupy shown in Table 2 revealed that the tenement housing also known as the Brazilian type was predominant in the study area [72%]; while the traditional, detached/semi-detached and blocks of flats had 12%, 2% and 14% respectively. Overcrowding, no doubt influences slum development; observations made during the field survey revealed that this type of building in the study area accommodates more family households. In a single face-to-face building, households between four [4] to six [6] was observed with an average of eight [8] rooms. This of course is one major characteristics of slum [overcrowding] which affects the state of health of residents. Evans, Wells, Chan and Saltzman [28] noted that overcrowding in houses has detrimental effect on both mental and physical health. Fig. 4 showed the pattern of tenement building at Odojoka.

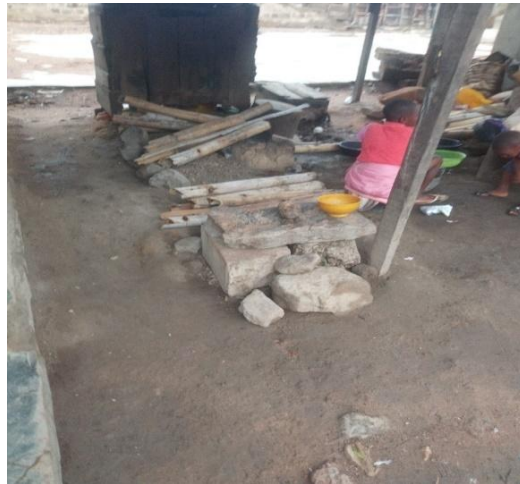
**Fig. 5. Kitchen Located Outside the Building at Isolo**  
 Source: Author's Field Survey, 2022

From the study conducted, it was discovered that most of the residents of the core do not have in-house kitchens. According to Table 4 most of the respondents' kitchen are detached and constructed separately within the same compound. Residents mostly use firewood to prepare their meals. Exposure to firewood smoke leads to respiratory diseases including acute respiratory illness and impaired lung function [30]. Food is prepared in the open where flies, domestic animals, rodents, reptiles and filth are present. It is not surprising why diarrhea and other forms of gastro-enteric disorders are common in the core districts [31]. Fig. 5 gave an example of a kitchen located outside the building at Isolo.

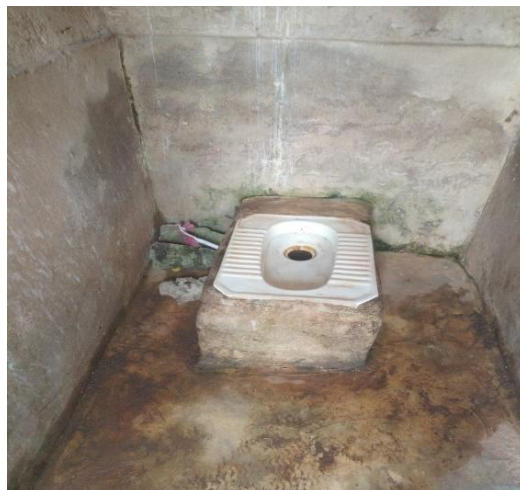
**Fig. 6. Pit Latrine with Modern Squat-Bowl at Oja-Oshodi**  
 Source: Author's Field Survey, 2022

consciousness of the toilets by the users is very low. Poorly maintained shared pit toilet facility is a breeding ground for diseases vectors and an avenue for transmission of communicable and infectious diseases [31]. Evidence of a pit latrine with modern squat-bowl at Oja-Oshodi is shown in Fig. 6.

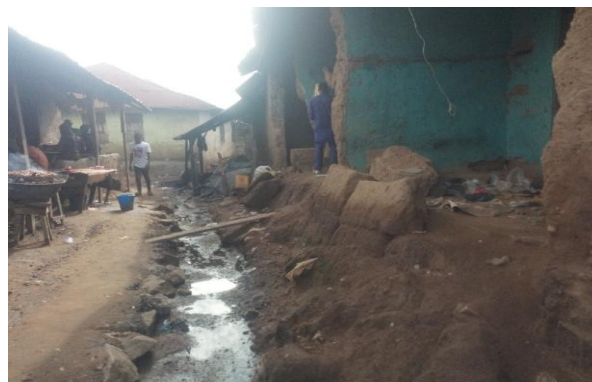
**Fig. 7. Dilapidated Building Constructed with Mud at Odojoka**

It was obvious from the field survey, that majority of the buildings in this study area were constructed with mud. As presented in Table 6, 72.9% of the buildings were constructed with mud while 27.1% was constructed with cement block. This clearly characterized the environment as slum. As a matter of fact, some of these buildings constructed with mud were not plastered with concrete; which is subject to wear and tear. It is not surprising that the deterioration of the environment can be linked with the construction materials employed in the study area. This housing material also established the fact that the buildings had been constructed many years ago, such as those that precedes modern planning. This shows that the level of technology of building construction in the study area is primitive. It was deduced from the survey that majority of these buildings are not in a sound state; they are mostly dilapidated and some almost falling apart. Fig. 7 showed dilapidated buildings constructed with mud at Odojoka where

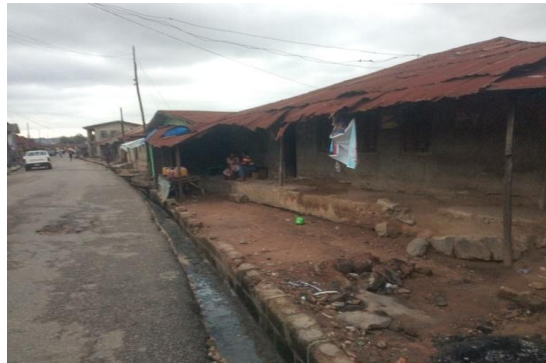
**Fig. 8. Dilapidated Corrugated Iron Sheet for Building Construction at Araromi**  
 Source: Author's Field Survey, 2022

Analysis as shown in Table 7 revealed corrugated iron sheet to be the prevalent roofing material used for the buildings in the study area. Corrugated iron sheet when exposed to sunlight, rainfall and humidity over time leads to rusting which changes the colour of the roof and subsequently becomes dilapidated. It is evident from the survey conducted that majority of these roofing sheets are dilapidated, flapping and leaking. The implication is that, when rain drops, residents are exposed to leakages of water coming from the opening of their roofs. Fig. 8 gave a typical example of a dilapidated roofing sheet at Araromi.

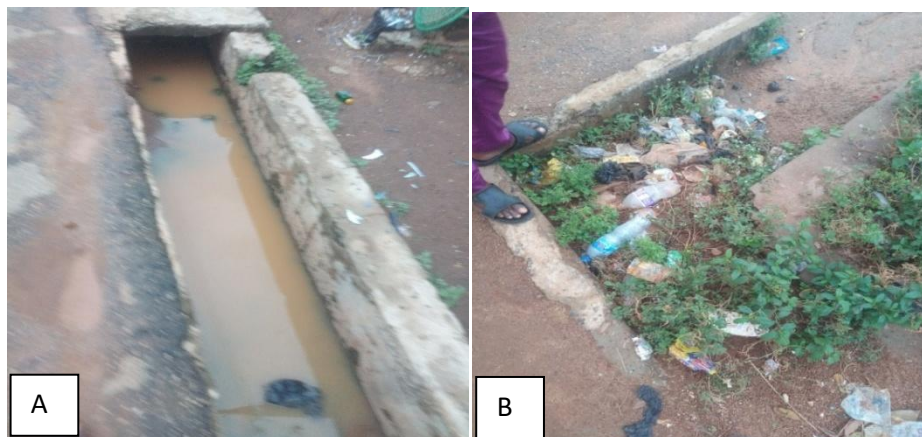
**Fig. 9A. Water logged drainage at Araromi, B: Blocked Drainage at Owode**  
 Source: Author's Field Survey, 2022

during this period. It was observed that some of the drainages produces obnoxious odour, this is connected to the attitude of some of the residents who deposit liquid waste from kitchen, bathroom and laundry indiscriminately to the drainages. This type of drainage condition breed mosquitoes which is the causative organism for malaria. The deposition of urine into the drainages also contribute to the foul smell emitted from these drainages, thus making it look unattractive. Fig. 9 [A & B] gave a clear picture of a water-logged and clogged drainage system respectively at Araromi and Owode.

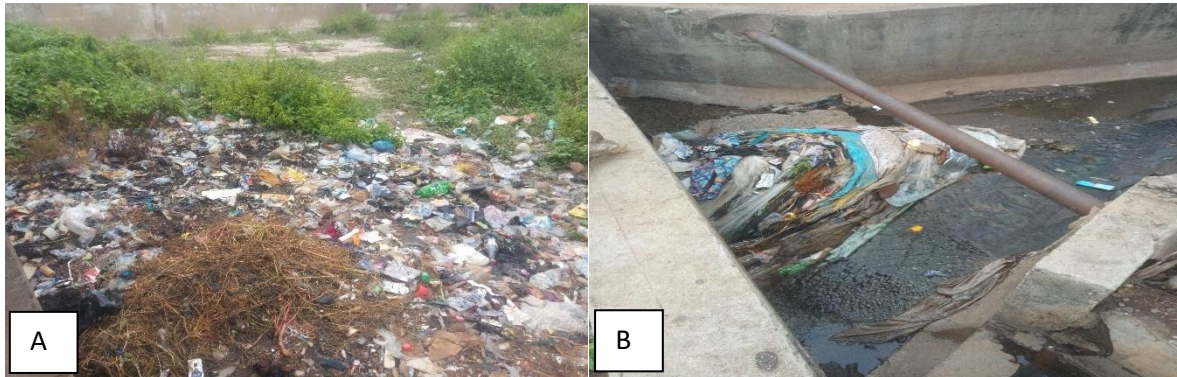
**Fig. 10A. Indiscriminate Disposal of Waste at Imuagun, B. Accumulated Waste in Odokoyi Drainage**

Analysis presented in Table 9 showed the waste management practices of the residents of the area under study. Data obtained from respondents revealed that the Ondo State Waste Management Board are in charge of waste collection in the area. A large proportion of the respondents [90.6%] revealed that the Waste Management Board do come with their trucks to evacuate waste generated by residents from the area. Despite the effort of the government in ensuring that the environment is kept clean, some still deposit their waste into open drains especially during rainfall, which causes the drainage to be water logged or completely blocked. Others deposit theirs in open spaces. This act harbor insects, rodents and some reptiles that is dangerous to the health of the residents. Fig. 10 [A&B] depicts the indiscriminate waste practice of residents at Imuagun and Odokoyi
